2 5th Avenue

New York, NY

**Concrete &
Masonry Repair
2012-2013**

Quickly and economically reface a 20 story façade while installing moisture protection.

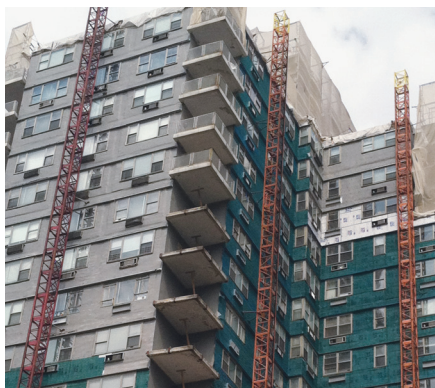
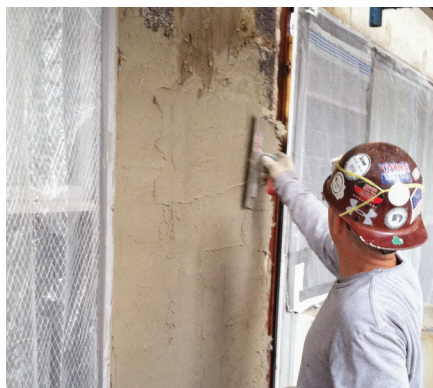
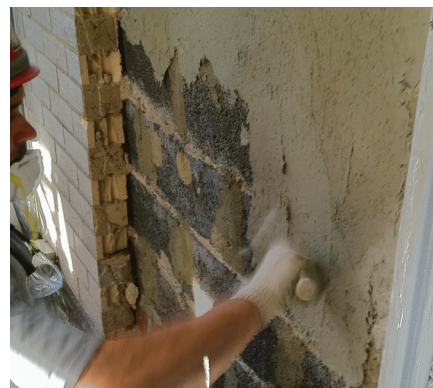
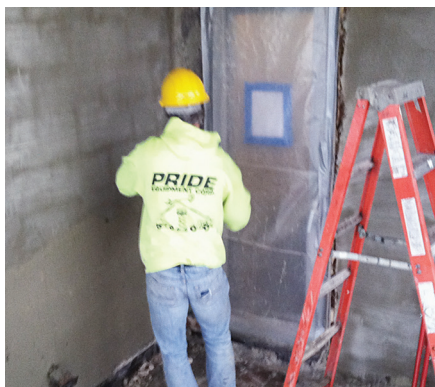
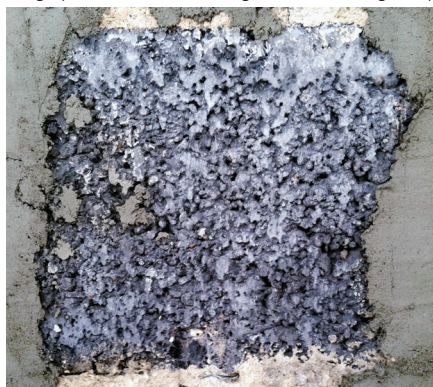
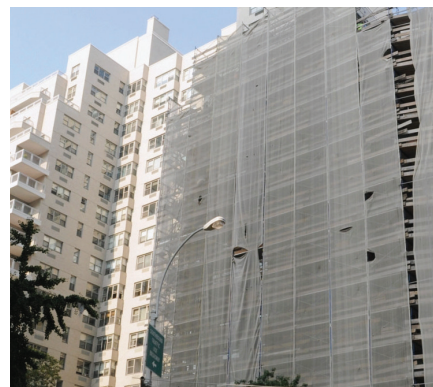
All photographs were taken "during" the work being completed.

This luxury co-op faced a very pressing and expensive issue. Areas of the façade's white glazed brick were buckling, leading the fire department to cordon off the street below, but investigation uncovered much more serious problems. The building had been constructed of cinder blocks with brick veneer. There was no air or vapor barrier insulation within the exterior wall system. In 2009, that system had completely failed.

All of the glazed brick and the terraces were removed, exposing a very irregular block surface. Steel supports were installed. Pinholes and voids were guaranteed if the liquid air barrier membrane was applied directly to the block, compromising that system. Structural Skin, a fiber reinforced

structural coating that shows a 100% reduction in water penetration and leakage per ASTM E514, was applied as a fairing coat at a depth of a quarter inch. This application not only provided a uniform surface for the air barrier, it offered secondary protection for the system by allowing moisture diffusion and acting as a moisture barrier, thereby also protecting the reinforcing steel supports from corrosion. A new brick veneer was then applied over insulation.
