# 250 W 50th Street

**New York City, NY**

**Concrete Repair and  
Protective Coatings  
2007**

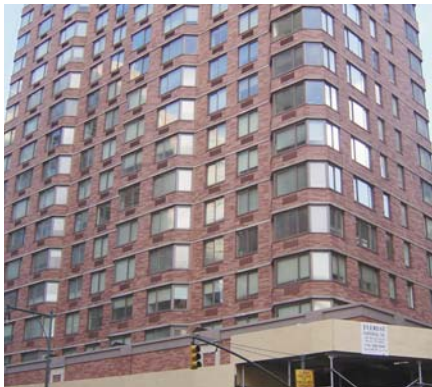
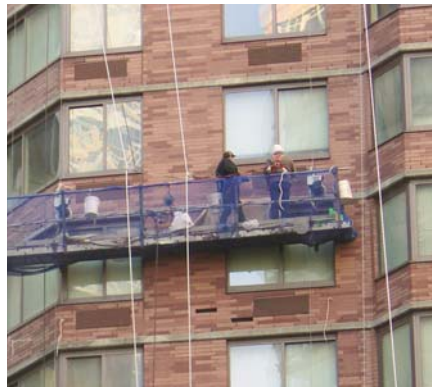
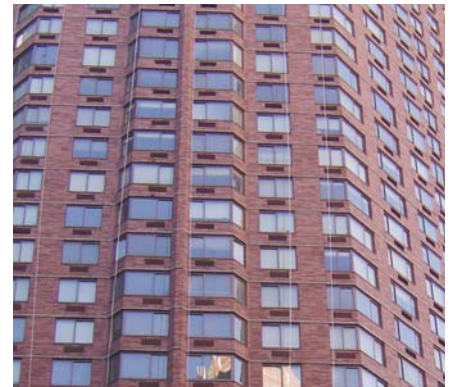
Top three photographs were taken "during" and the bottom three photographs were taken "after" the work was completed.

The edges of each floor slab are exposed to the building exterior, creating a band or "eyebrow". Often during construction, reinforcing steel is placed too close to the edge of these slabs, which creates a condition where there is insufficient concrete cover to protect the steel. The reinforcing steel corrodes, and concrete spalls result.

C & D Restoration used ECB, an anti-corrosion coating and primer on all exposed rebar. ECB is single component, with a long open time. It prevents anode transfer and will not cause delamination due to temperature change. Patching was then done with Conpro Set, which also features ECB-Tech corrosion protection. Conpro Set is durable, resists cracking and

has very low permeability which protects against carbonation and chloride.
