# Danville State Hospital

**Danville, Pennsylvania**

**Stone Repair**  
**Exterior Wall Systems**  
**Summer 2007 – Summer 2008**

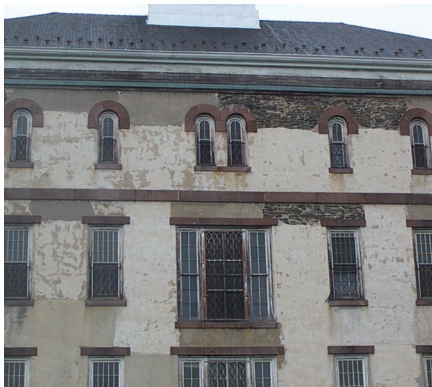
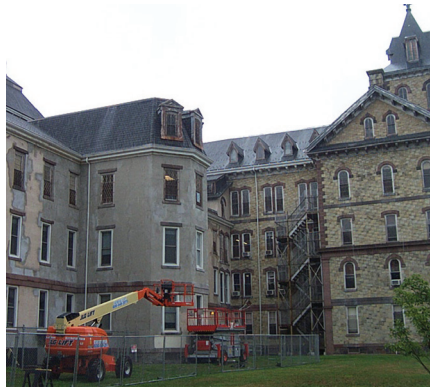
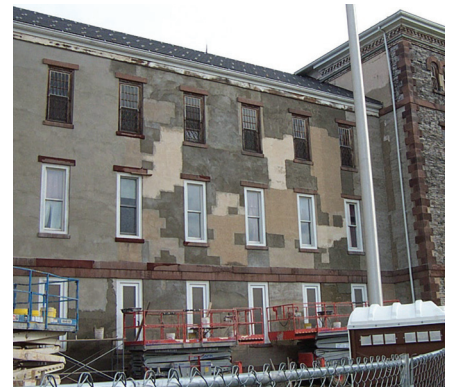
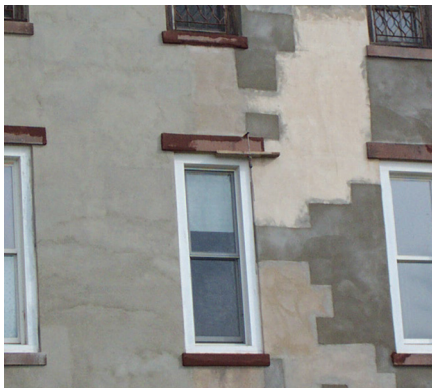
Top three and bottom left photographs were taken "before and during" and the bottom center and right were taken "after" the work was completed.

Widespread stucco damage prompted this restoration. C & D Waterproofing stripped all areas of deteriorated and delaminated stucco back to original substrate, square cutting edges to an average depth of 1" - 1.5". Conpro One Coat was applied directly to the substrate, without the need for expanded wire mesh. Conpro One Coat may be applied in thicker lifts than traditional stucco, making it the ideal material to replace the original scratch and brown coats.

The brownstone accents were repaired with MIMIC, which was slightly overbuilt and then shaved to achieve the same surface texture as the original stone. Simple forms were used to speed installation in some areas. Once cured, the MIMIC was an excellent match, providing a beautiful finishing touch to a unique restoration.
