Audubon High School Grandstand

Audubon, New Jersey

**Concrete Repair
and Protection**
Winter 2004 – Spring 2005

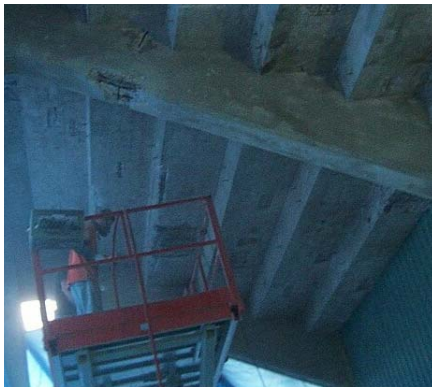
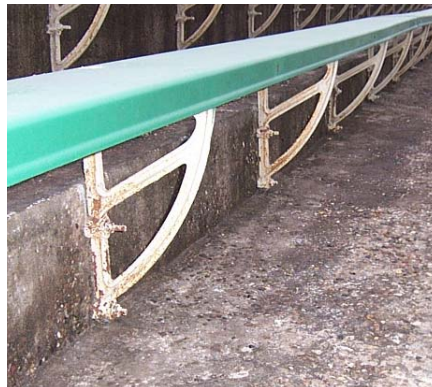
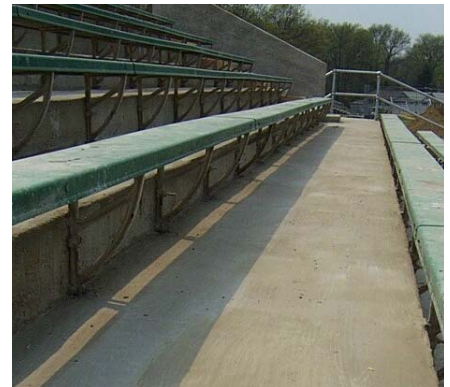
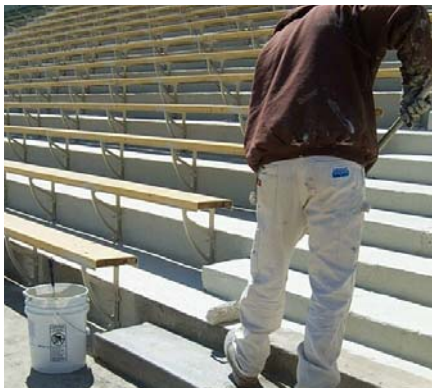
Top three photographs and bottom left are "before" and "during"; the bottom center and right were taken after the work was completed.

Audubon High School grandstand was built in 1936. The cast-in-place concrete structure served the school well through many championship seasons. Physical wear, corrosion of steel reinforcing, deicing salts, acid rain and freeze/thaw cycling all played a role in the spalling and deterioration of concrete surfaces. Water consistently leaked into storage and concession areas under the grandstand. The architect, structural engineer and school district formulated a repair strategy designed to restore the structural elements,

Repair spalling concrete, resurface and install protective wear surface.

Extensions to widen each of the steps on the main stair aisles were poured to bring them up to current code. Conpro Primer was applied first to the existing concrete to improve adhesion. The bleachers were cut back along these aisles to accommodate the new, wider stairs. The lowest treads

and risers were filled with concrete to make a doublewide tread area for wheelchair use.
