Development of a Crack-Resistant Rubber-Modified Cementitious Repair Material

From compatibility concepts to the field

by Alexander M. Vaysburd, Benoit Bissonnette, and Christopher D. Brown

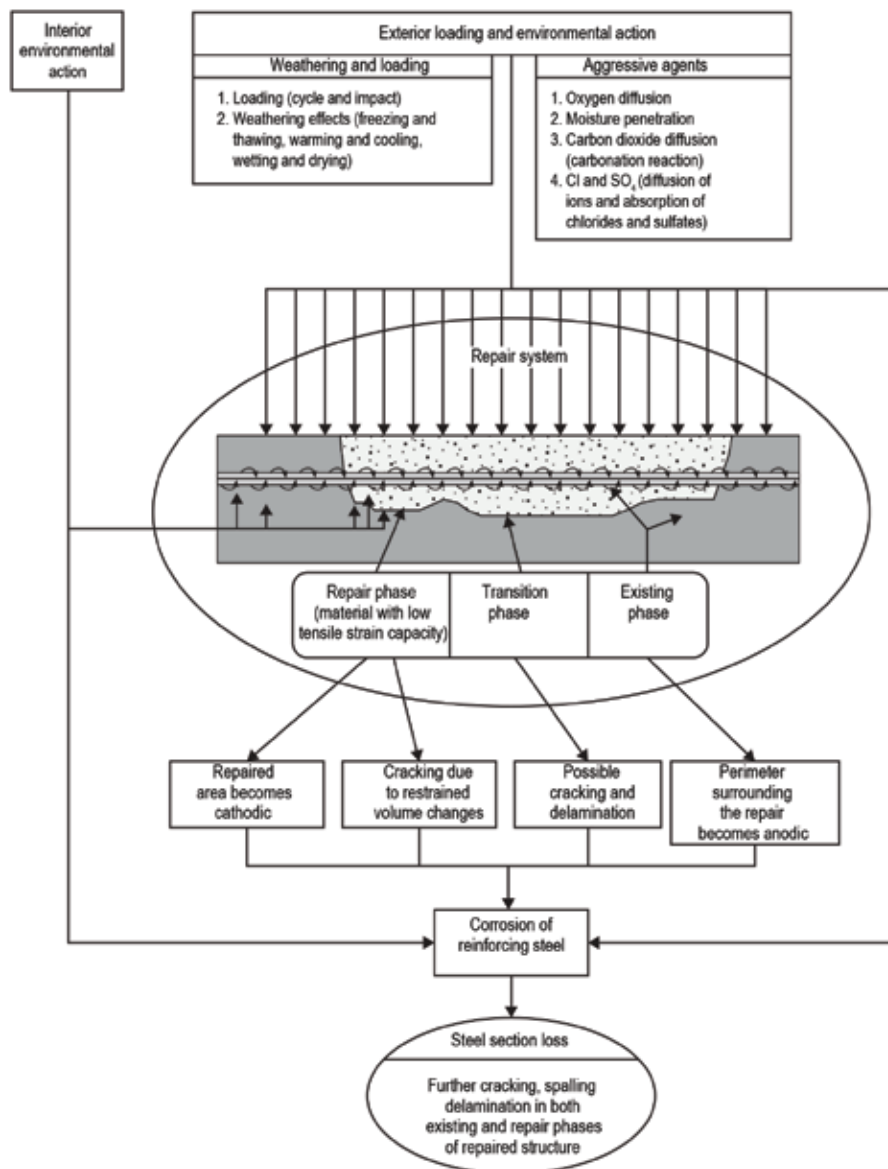
Fig. 1: Model of repair failure caused by cracking³

Cracks generally interconnect flow paths and thus increase effective permeability of the repair material. The resulting chain reaction of cracking → more permeable repair → corrosion of reinforcement → more cracking may eventually result in irreversible deterioration and failure of the repair. Some 50 years ago, Valenta² observed that “continuous cracks linking into wider cracks originating from the concrete surface play the biggest role in increasing permeability.” Figure 1 schematizes a model of repair failure caused by cracking.

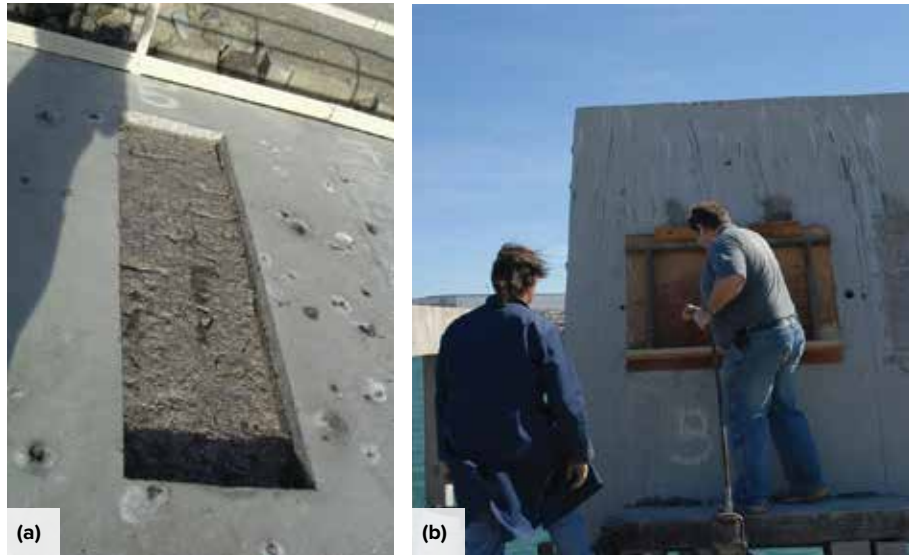
Fig. 6: Repair areas selected for field experiments at the U.S. Navy facility in Port Hueneme, CA, USA: (a) horizontal, on the pier, 73.5 x 19.5 in. (1840 x 490 mm) and 3 in. (75 mm) deep; and (b) vertical, on an existing slab installed upright next to the selected pier, 48 x 36 in. (1200 x 900 mm) and 3.5 in. (88 mm) deep⁵

The horizontal repair was located on a pier deck slab (Fig. 6(a)), and the vertical repair was located on a slab that was rotated to the vertical (Fig. 6(b)). The repair dimensions were chosen to be representative of the geometrical proportions and the surface-area-to-volume ratio of typical surface repairs made on Naval facilities. Formwork for the vertical repair was constructed using plywood in accordance with the applicable provisions of ACI 347R-14,¹⁴ and it included two chutes (“bird mouths”) on the top for concrete placement.

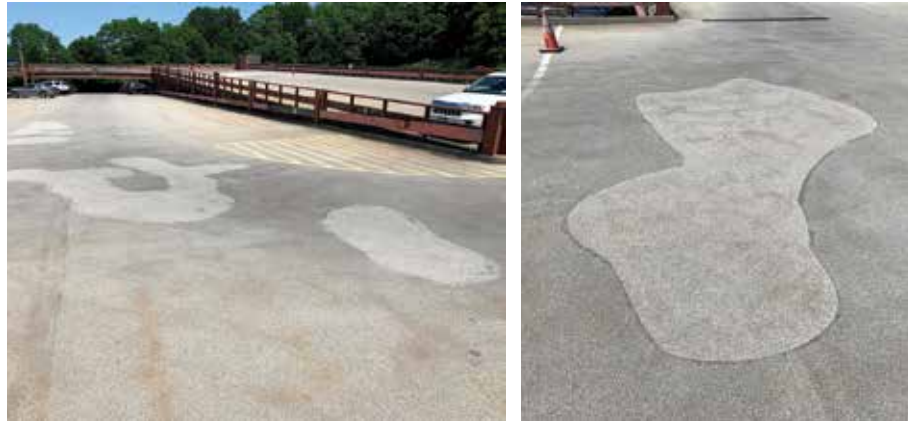
Fig. 7: A parking garage deck in Utica, NY, USA, repaired with the rubber-modified repair material, after 4 years in service

selected for its lower shrinkage-cracking sensitivity. The job involved patch repairs and then resealing of the exposed areas. As shown in Fig. 7, the patches had somewhat unusual geometries. The repairs were also shallow in some areas, and the exposed reinforcement was generally not undercut. Even so, no debonding, cracking, or bond line shrinkage have been observed after 4 years in service.
