Bryant University Center

Smithfield, Rhode Island

**Concrete Repair
Protective Coatings**
July 2005

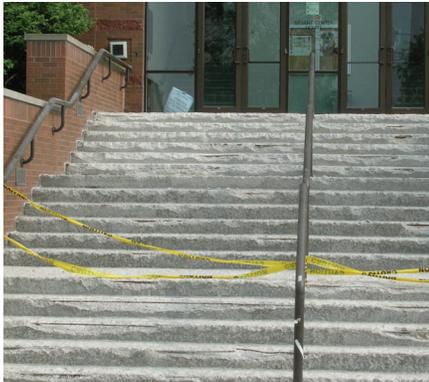
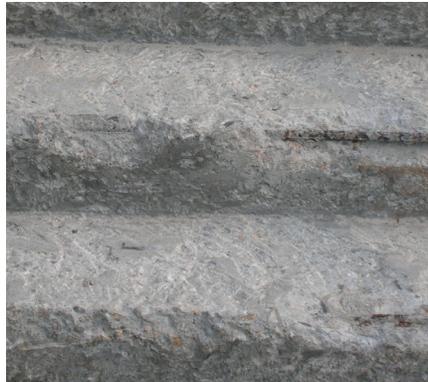
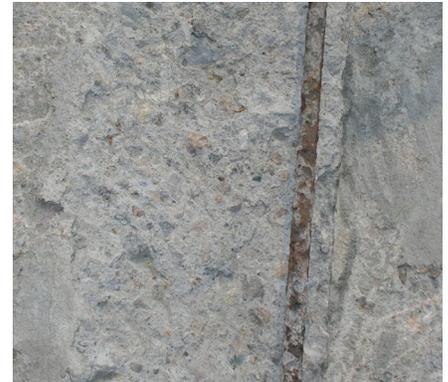
Top three photographs were taken "before" and the bottom three were taken "after" the work was completed.

The outdoor staircase leading into the Student Center exhibited signs of deterioration, and needed to be repaired due to a concern for student safety. Showing some exposed rebar and failing concrete, the university had to work quickly to restore the campus' professional appearance.

The Waterproofing Company started by using bushhammers to get down to clean, sound concrete. Conpro Primer was used to provide a Velcro-like connection between the substrate and

repair materials. Conpro Set was used to repair the vertical surfaces, while One Shot Ag was used to repair horizontal surfaces, and in some cases correct elevation differences. Top Coat provided a clean and skid-resistant finish, as well as added waterproofing protection. Top Coat is specially suited for areas facing pedestrian traffic.
