Building #1

Henrietta, New York

Protective Coatings
July 2001 – August 2001

Restore an exterior plagued by white deposits.

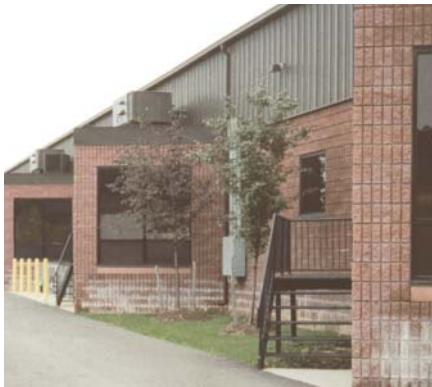
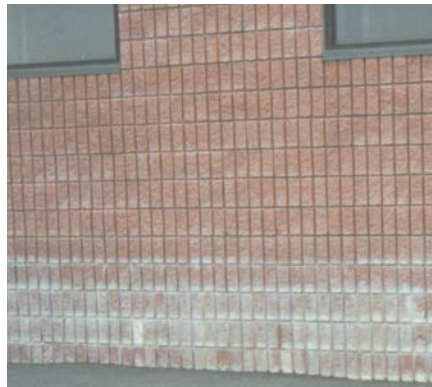
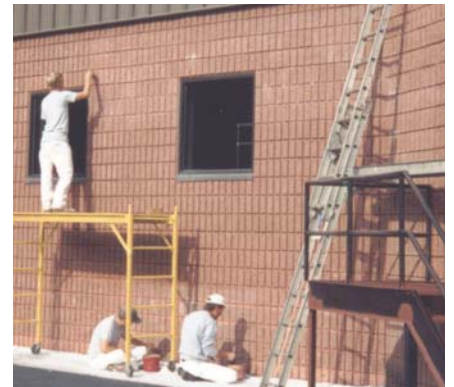
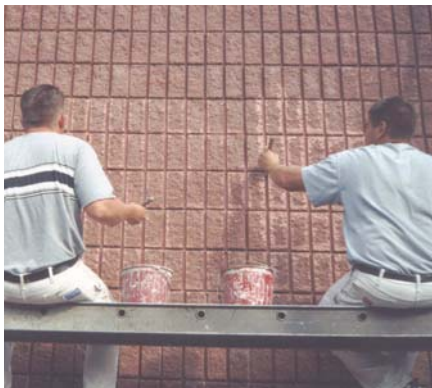
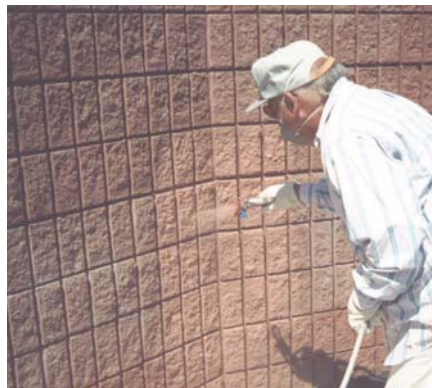
Top three and bottom left and center photographs were taken "before and during" and the bottom right was taken "after" the work was completed.

The building's lower exterior had developed unsightly white deposits. The discoloration was caused by a process called efflorescence. During construction, water accumulated in the CMU. Water dissolved and transported soluble salts through the masonry wall façade. When the moisture dried, the white salts remained.

Chemical cleaning proved ineffective. Mechanical cleaning would have affected the texture and appearance of the ribbed blocks, and so was avoided. Wire brushing accomplished the task of prepping the substrate without damaging the building.

Super Color Stain VO provided the two necessary components for a successful restoration; water repellency and color matching. The stain's water repellent properties avoid salt transport in the future.

Spray application was used to reduce labor costs.
