# Carlisle Theater

## Carlisle, Pennsylvania

**Stone Repair**  
**Protective Coatings**  
**Water Repellents**  
 Fall 2005 – Spring 2006

Repair and restore the terracotta façade tiles, and provide water protection.

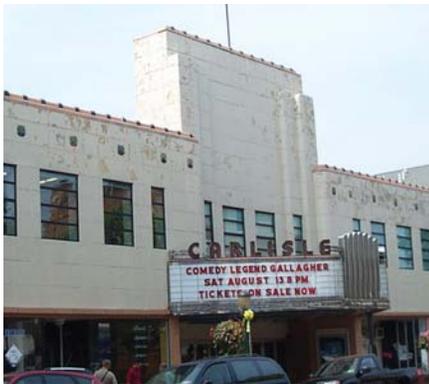
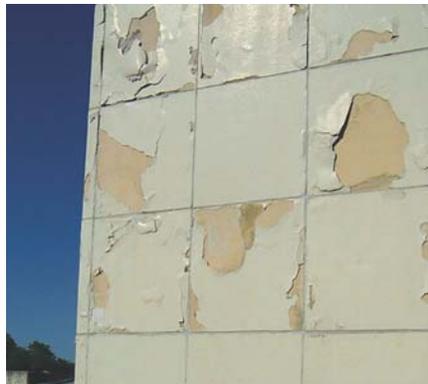
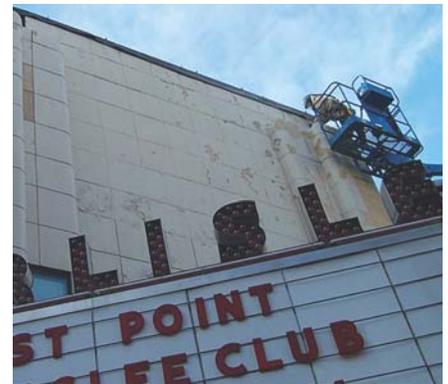
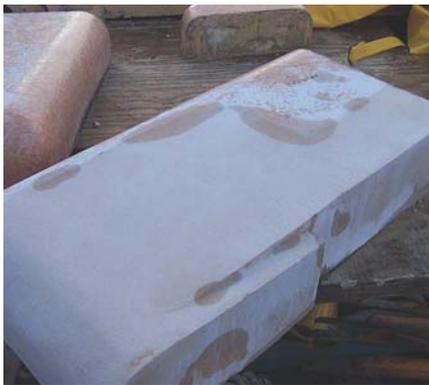
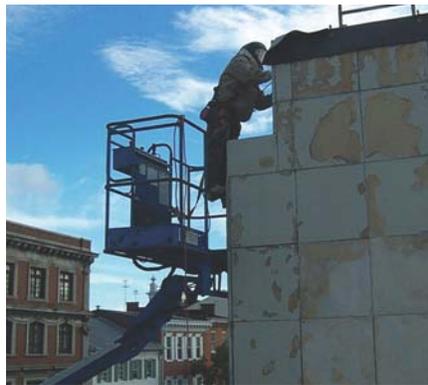
Top three and bottom left and center photographs were taken "before and during" and the bottom right was taken "after" the work was completed.

Roofing membrane extended up the entire length of the parapet, leaving water trapped and causing considerable damage.

Coping was removed and new copper flashing installed. The contractors terminated the roofing membrane at a lower level, and treated the bricks with Conpro Shield W. This prevented water entry through the parapet, while allowing water vapor to escape. Shallow spalling of the terracotta was repaired using MIMIC TR. The original finish was replicated by using custom-matched Color Coat, followed by Terracotta Gloss Finish. Today, the Carlisle Theater serves as a cultural focal point for the historic town and its performing artists.
