Purnell Hall

Newark, DE

**Concrete Repair
and Protective Coatings**
Spring 2012

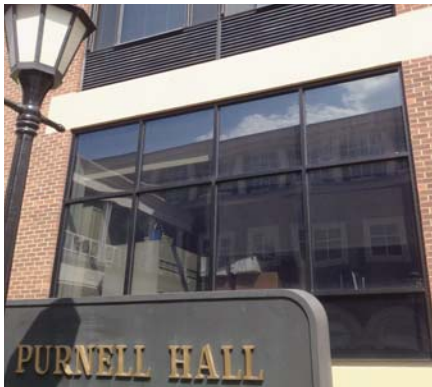
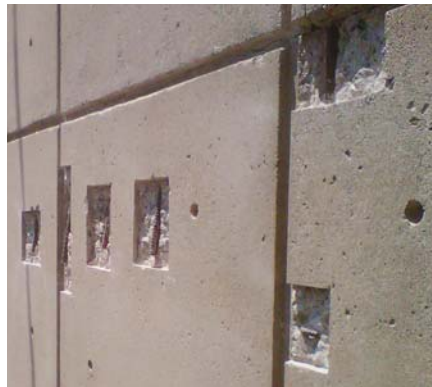
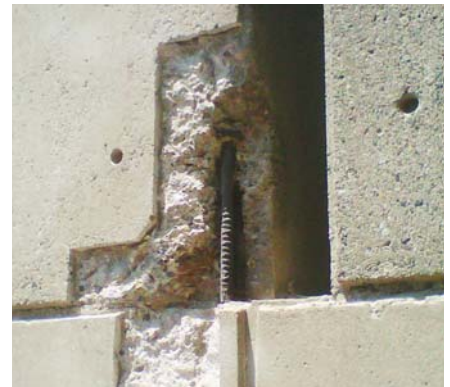
Top three photographs were taken "during" and the bottom three photographs were taken "after" the work was completed.

Concrete accents were repaired using ECB corrosion inhibitor and primer on all exposed rebar.

Hand patching was done with Conpro Set. Conpro Lastic elastomeric coating was then used on all vertical concrete.

Balcony decks were refinished using Elastideck, a flexible cementitious coating. They were then coated with Super Color Stain, which improves dirt and stain resistance. Color Coat, a waterproof lightweight acrylic coating was used on the balcony soffits.
